**Operator Presence Water Ball Valve  
Hardware**

**Bulletin Name:** MXR-TSIB-030

**Models:** Bridgemaster Mixer and  
Standard Mixer

**Affected Units:** Mixers with optional operator  
presence water ball valve

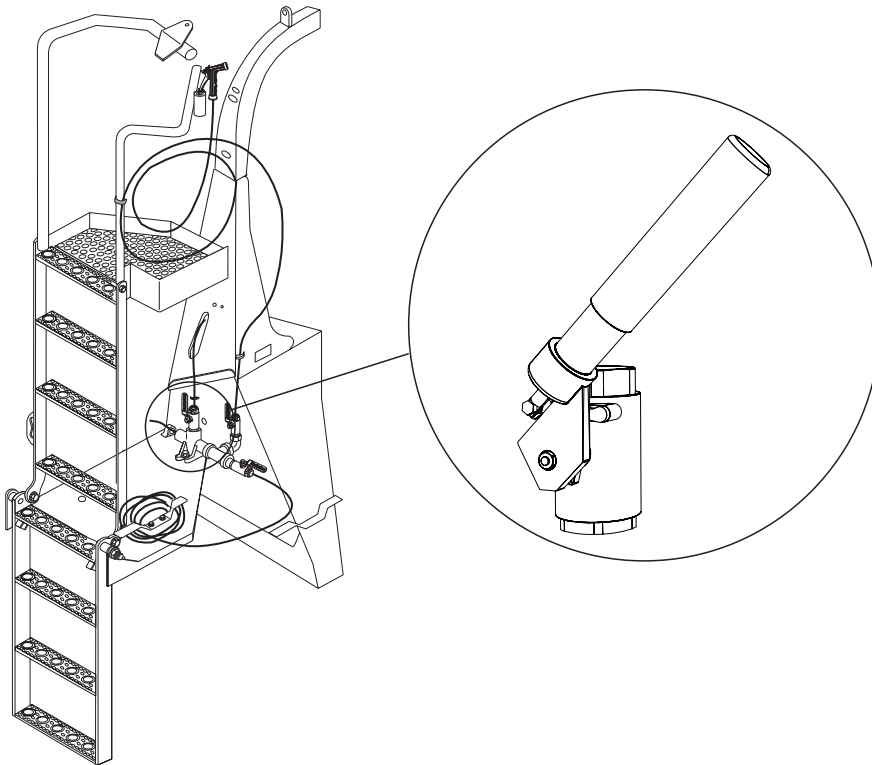
Figure 1: Operator Presence Water Ball Valve Location.

1. Place vehicle on a flat surface, block truck tires, and observe all conditions of the Safety Notice concerning Lockout/Tagout posted in the Notice section of this bulletin.
2. Locate the operator presence water ball valve on the vehicle. See Figure 1.

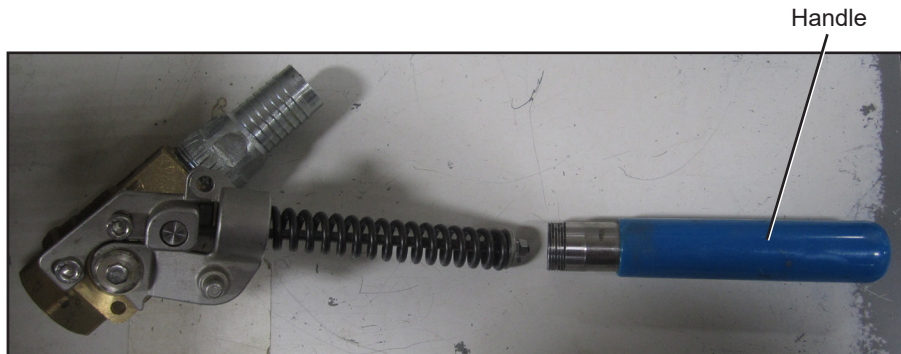
Figure 2: Handle Removed from Ball Valve Assembly..

3. Remove the handle from the ball valve assembly. Turn the handle counter-clockwise to unscrew the handle from the valve assembly. See Figure 2 (valve assembly shown removed from Mixer for illustrative purposes only).

6. Reinstall the handle onto the ball valve assembly. Turn the handle clockwise and screw the handle into the valve assembly. See Figure 2.
7. Procedure is complete.

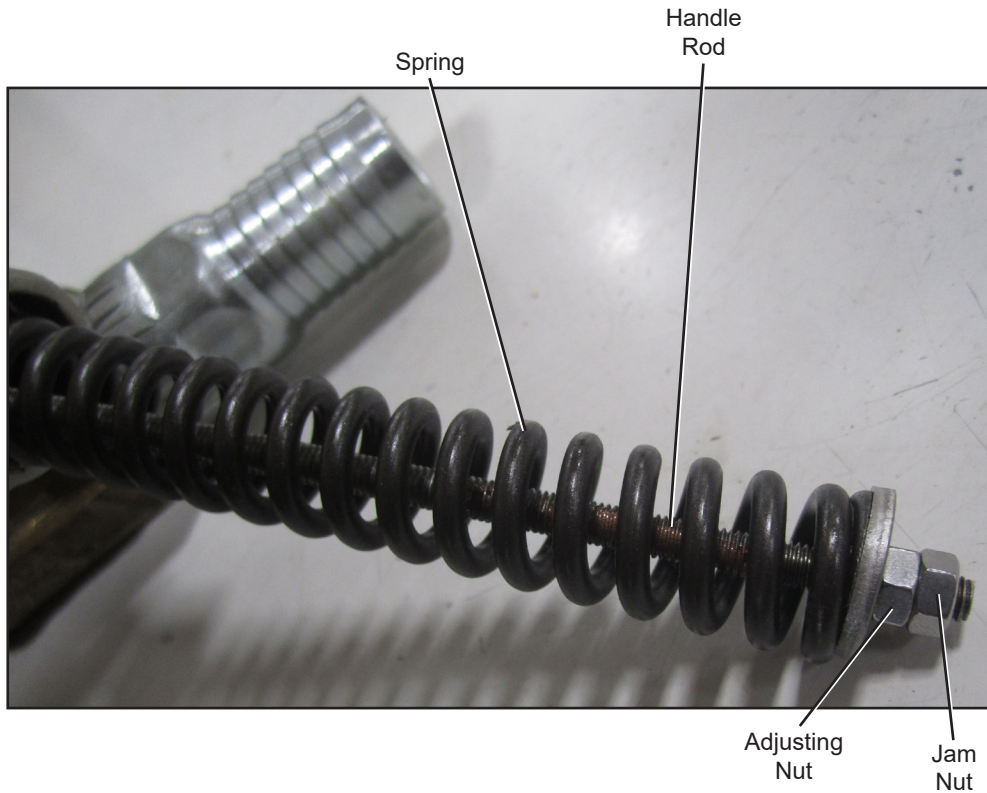
McNeilus Truck and Manufacturing requires the inspection of the one inch operator presence water ball valve handle on Bridgemaster Mixers and Standard Mixers. An adjusting nut and a jam nut should be present. If neither nut is present or if only one nut is present and is loose, there can be insufficient spring tension on the operator presence handle. This can lead to the valve opening and water being added to the drum without the driver knowing. Removal of the valve handle is required to check if the two nuts are present.

Figure 3: Ball Valve Handle Assembly.

4. Check there are two nuts securing the spring to the handle rod. See Figure 3. If there are two nuts, check that the jam nut is torqued to 4.5 ft.-lbs. (6 N•m), then continue to Step 6. If there is only one nut, continue at Step 5.
5. Install an additional nut (P/N 1245279) onto the rod and use a torque wrench to torque the jam nut to 4.5 ft.-lbs. (6 N•m).
