**Mid-Continent Concrete Co. / GCC
Bridgemaster V Nylon Reservoir Filler
Neck Replacement**

Date: April 26, 2018
Bulletin Name: MXR-TSB-025
Model: Bridgemaster V
Model Year: 2008 - 2018
Units Affected: Units with Nylon Hydraulic Reservoirs

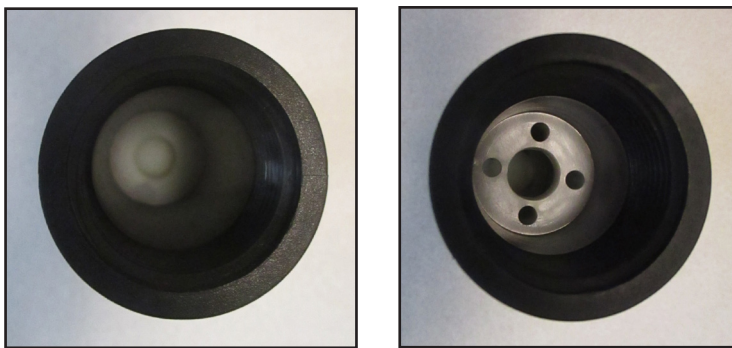
Figure 2

NOTE: The existing filler neck has one visible hole when looking at it from the top while the new filler neck (P/N 1570075) has five visible holes (see Figure 2). If you already have a filler neck with the five holes, and the filler neck is not damaged, there is no need to replace it. Skip to Step 8. If you have a filler neck that does not have five visible holes as shown (Figure 2, right side image), the filler neck must be replaced. Continue with the rest of this bulletin.

Existing Neck - 1 hole

New Replacement Neck - 5 holes
