Mixer Lower Ladder Platform Weld Inspection

Date: 06-09-15
Bulletin Name: MXR-TSB-024
Model: Mixer
Affected Units: Bridgemaster V Mixer and Standard Mixer

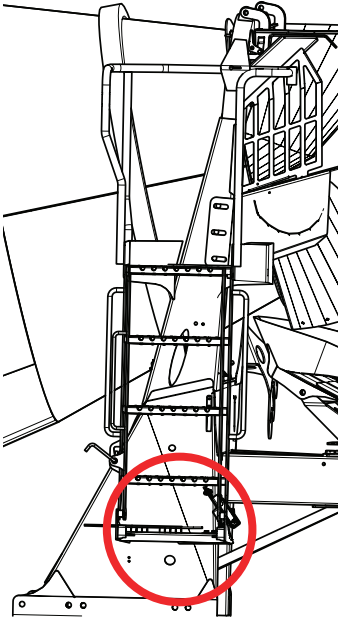
Figure 1: Locate the lower ladder platform.

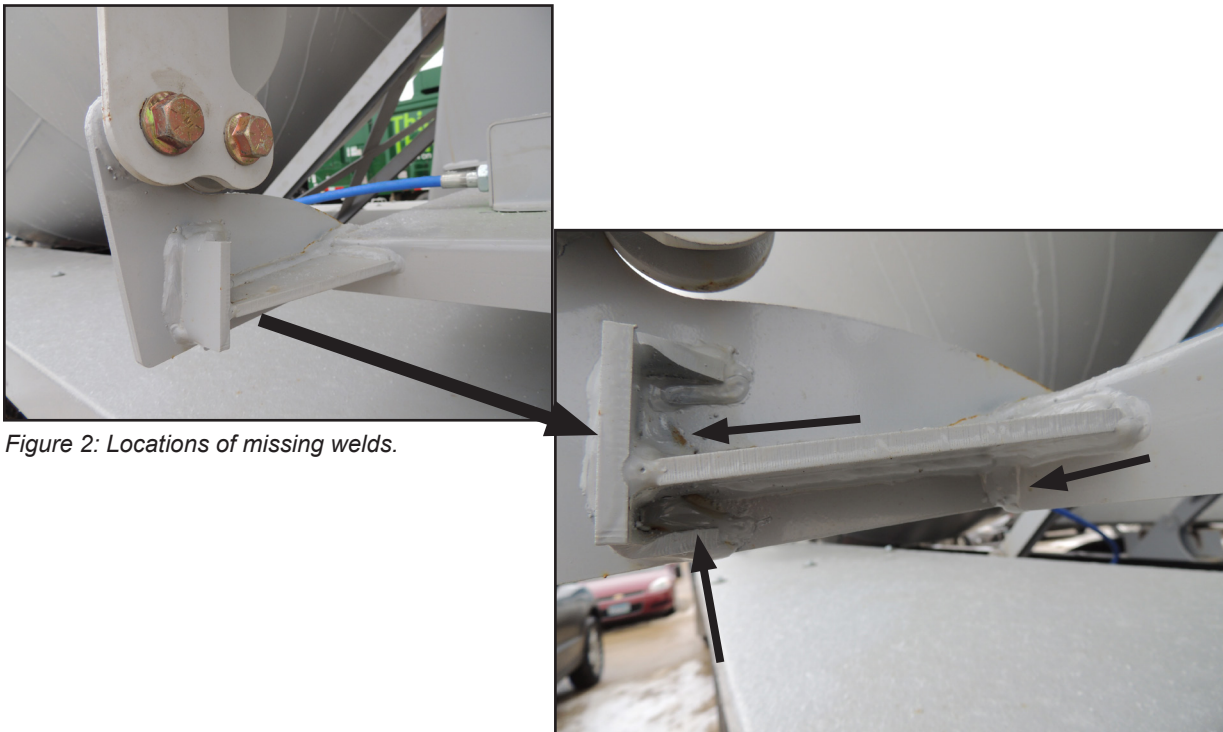
McNeilus Truck and Manufacturing requires the inspection of mixer lower ladder platform welds on Bridgemaster V Mixers and Standard Mixers. A vendor manufactured lower ladder platform may not have been manufactured with all the necessary welds. The amount of weld currently on the platform is enough to be structurally sound. However, if the welds are not present, McNeilus requires the ladder platform be replaced because of the possibility of corrosion on an unwelded platform. There is no affect to driving capabilities of the Mixer vehicle.

Figure 2: Locations of missing welds.

The existing lower ladder platform must be removed and discarded.
