Vehicle Safety Recall - Technical Service Bulletin

Attention: McNeilus Product Owner
Subject: Bridgemaster V nylon reservoir filler neck replacement
Model Affected: Bridgemaster V 93
Model Years: 2008-2018
Date: August 2019

PROCEDURE: Filler neck inspection for correct part replacement

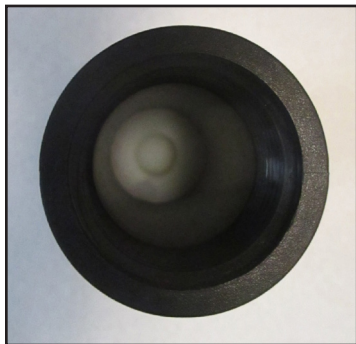
Figure 2

3. Inspect the filler neck.
 - If it has one visible hole when looking at it from the top (Figure 2), then it is the **incorrect** part. Continue with the rest of this bulletin to replace the incorrect part with the correct part.
 - If it has five visible holes (Figure 3), then it is the correct part and there is no need to replace it. Screw the cap back onto the filler neck. Proceed to Step 8 to finish the bulletin.

Incorrect Neck - 1 hole

4. Inspect all additional filler neck parts you have on hand that are not installed on a vehicle.
5. Order the new, correct filler neck part from McNeilus by calling 888-686-7278 or visiting www.streetsmartparts.com. The part number of the filler neck is 1570075. Order as many filler neck parts you need to replace all incorrect filler neck parts.
6. When you have received the correct filler neck, install it according to the following steps.
7. Remove the existing filler neck from the reservoir. Keep the existing filler neck to be returned to McNeilus Warranty following the normal warranty claim process.
8. Remove the cap from the existing filler neck.
9. Screw the cap onto the new filler neck (Figure 4).

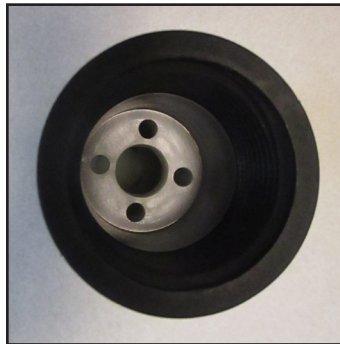
Figure 3

Correct Neck - 5 holes
