Vehicle Safety Recall - Technical Service Bulletin

Attention: McNeilus Product Owner
Subject: Mixer Vertical Chute Rack for Steel or Aluminum Chutes
Models Affected: All Mixers
Date: May 2014

Vertical Chute Rack and Chute Stop Inspection and Replacement Procedure

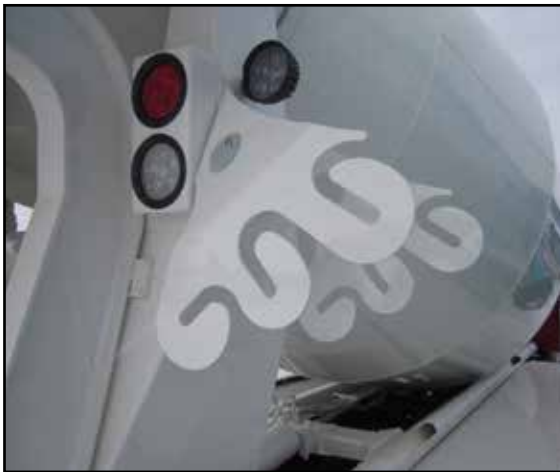
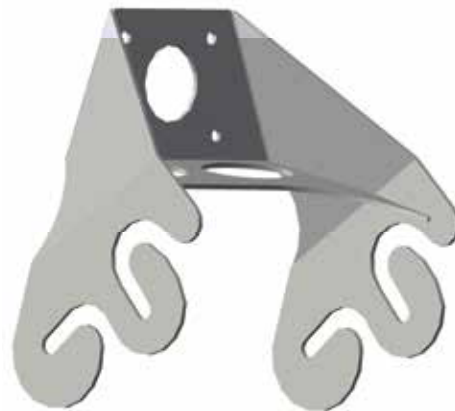
Figure 1: “Old” Style Chute Rack **does not need to be replaced**. On left is the three chute rack design, and on the right is the two chute rack design.

- If the chute rack looks like Figure 1, the rack is acceptable and no action is required (“old” chute rack style). The truck may be returned to service. (Note: Images for both the two chute rack design and the three chute rack design are provided.)

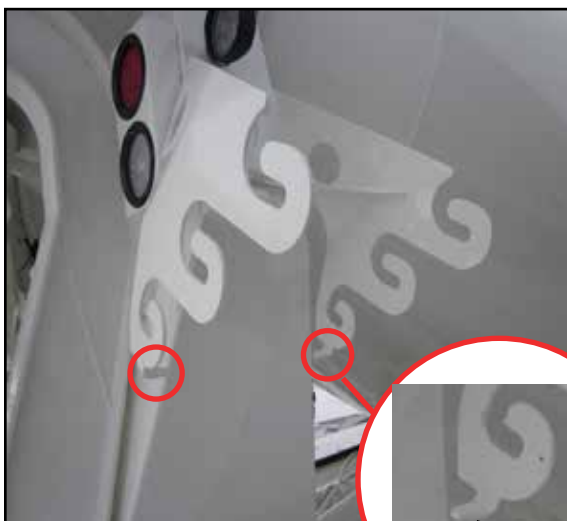
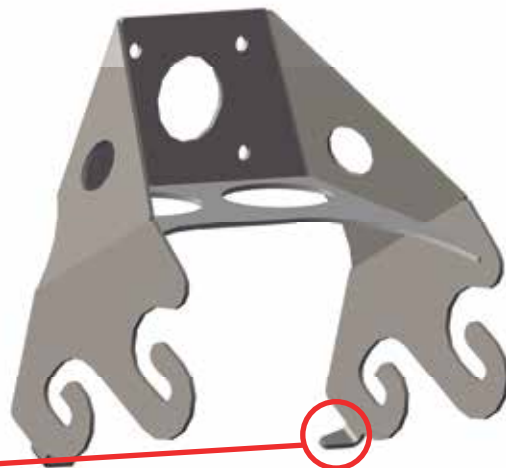
- An obvious difference between the old chute rack style and the recalled chute rack style is that the recalled chute rack has two bent tabs on the bottom rack (Figure 2).

Figure 2: “Recalled” Style Chute Rack **must be replaced**. On left is the three chute rack design, and on the right is the two chute rack design.

McNeilus Truck and Manufacturing, Inc. has decided that a concern affecting safety exists in some vertical chute racks. The vertical chute rack can allow extension chutes to unexpectedly detach from the rack while in transport. The result of chutes detaching from the vehicle creates a possibility of a road hazard, which could result in a vehicle crash or injury. In the interest of motor safety and customer satisfaction, McNeilus has elected to initiate a voluntary recall to allow us to formally recall all affected units. This remedy must be completed on all affected units.

- If the chute rack looks like Figure 2, the rack must be replaced (“recalled” chute rack style). (Note: Images for both the two chute rack design and the three chute rack design are provided.)

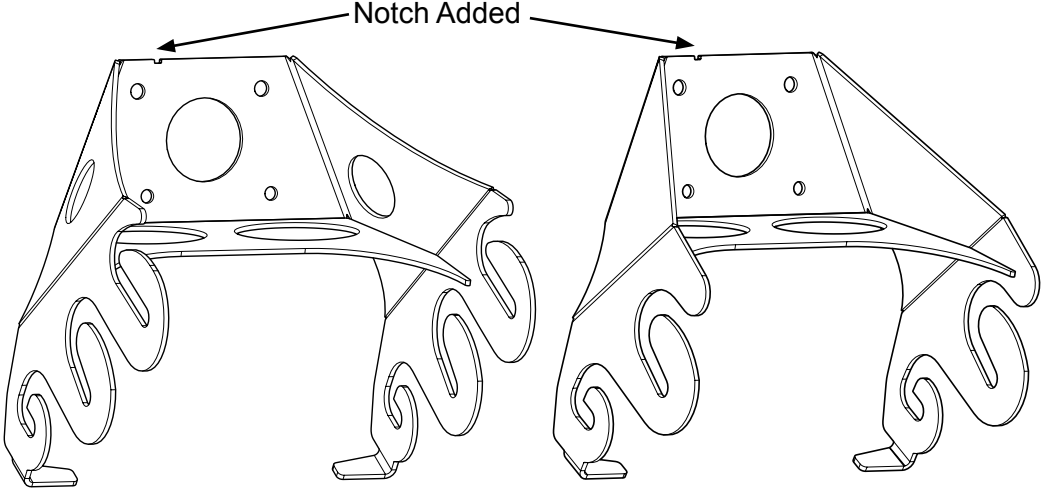
Figure 3 shows the NEW style chute rack designs (1503879 or 1504170) that will replace the “recalled” designs.

Figure 3: NEW chute rack designs (1503879 for the 3 chute design, 1504170 for the 2 chute design).

2. Install and align the new chute rack, **P/N 1504170 for the two chute rack design** or **P/N 1503879 for the three chute rack design**, on the truck in the same location from which you removed the existing chute rack.

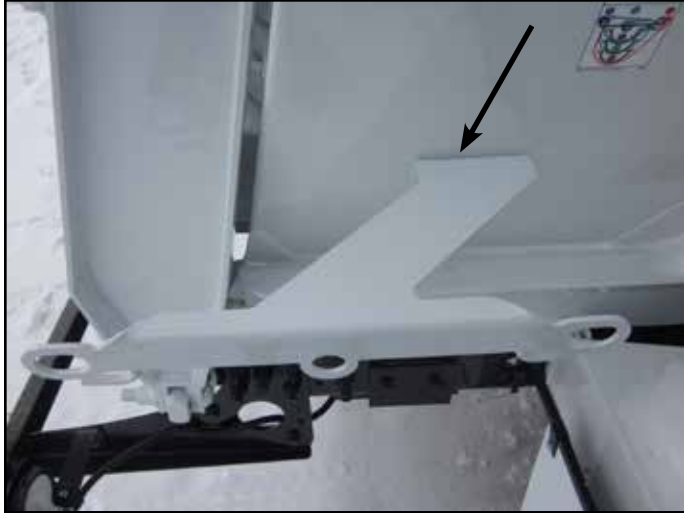
Figure 4: Offset Style Chute Stop must be replaced.

3. If the chute rack must be replaced, inspect the rack for an offset style chute stop.
 - If the rack has an offset style chute stop (Figure 4), the chute stop must also be replaced. See Procedure 3 for more information to replace the offset chute stop.
 - If the rack has a straight style chute stop (Figure 5), then the chute stop does not need replacing.

1. Remove the existing offset chute stop by removing the mounting hardware that secures the chute stop to the truck. Discard the existing chute stop and hardware.
2. Install and align the new offset chute stop (P/N 1503170) on the truck in the same location from which you removed the existing chute stop (Figure 7).
3. Secure with the new hardware provided: (4) P/N 1243670 Bolts, (4) P/N 0120200 Nuts (Figure 7).

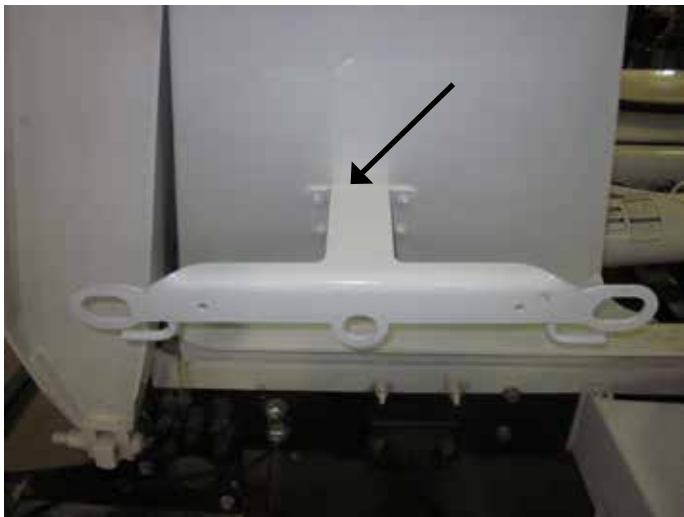
*Figure 5: Straight Style Chute Stop **does not** need to be replaced.*

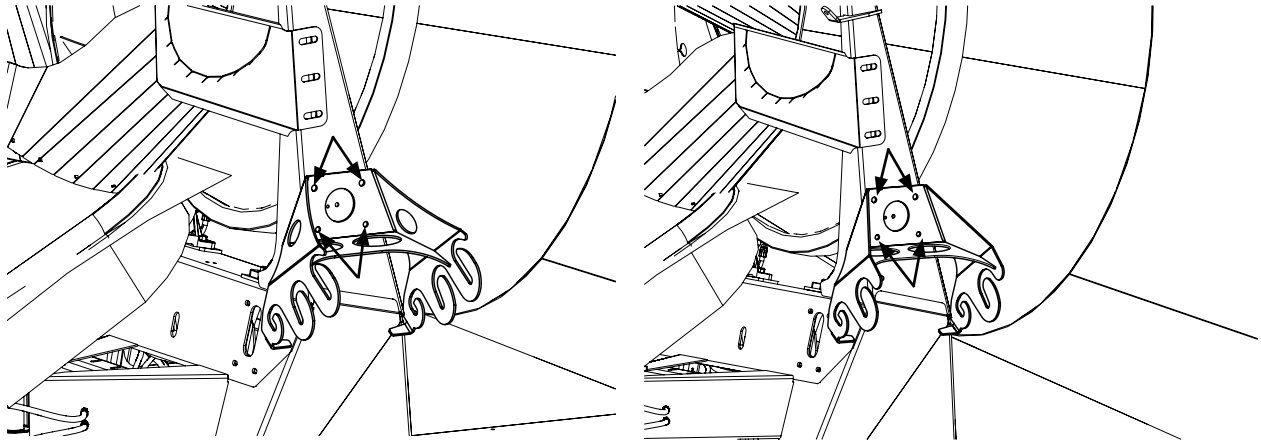
Figure 6: Place and secure the new chute rack on to the truck with the provided hardware. On left is the three chute rack design, and on the right is the two chute rack design.

3. Secure the new chute rack on the truck using the new hardware provided: (4) P/N 1164989 Bolts, (4) P/N 0120202 Nuts. See Figure 6 for securing location of the chute rack on the truck (the three chute rack design is shown in Figure 6 for illustrative purposes. Install and attach P/N 1504170 for the two chute rack design in the same manner).

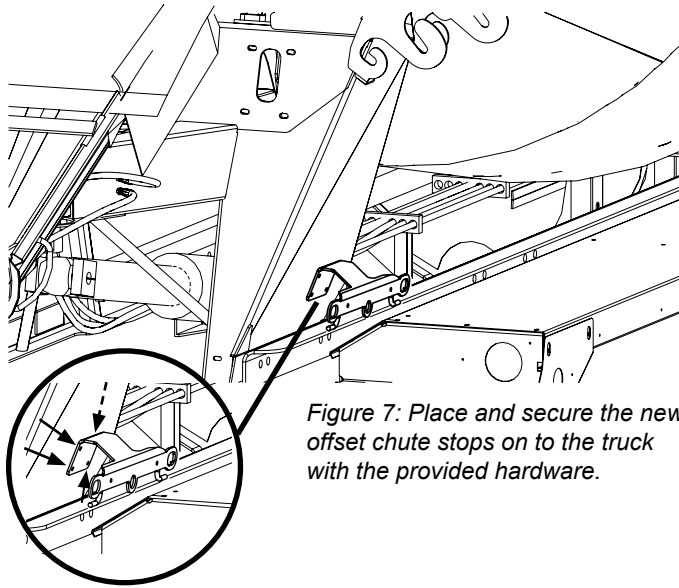
Figure 7: Place and secure the new offset chute stops on to the truck with the provided hardware.
